June 28, 2019
File No. 262018.063

Subject: Department of Natural Resources Washington Geological Survey,
School Seismic Safety Assessment Project, Contract No. AE 410 -
Seismic Evaluation for **Port Townsend School District**

School Buildings Evaluated in the Port Townsend School District

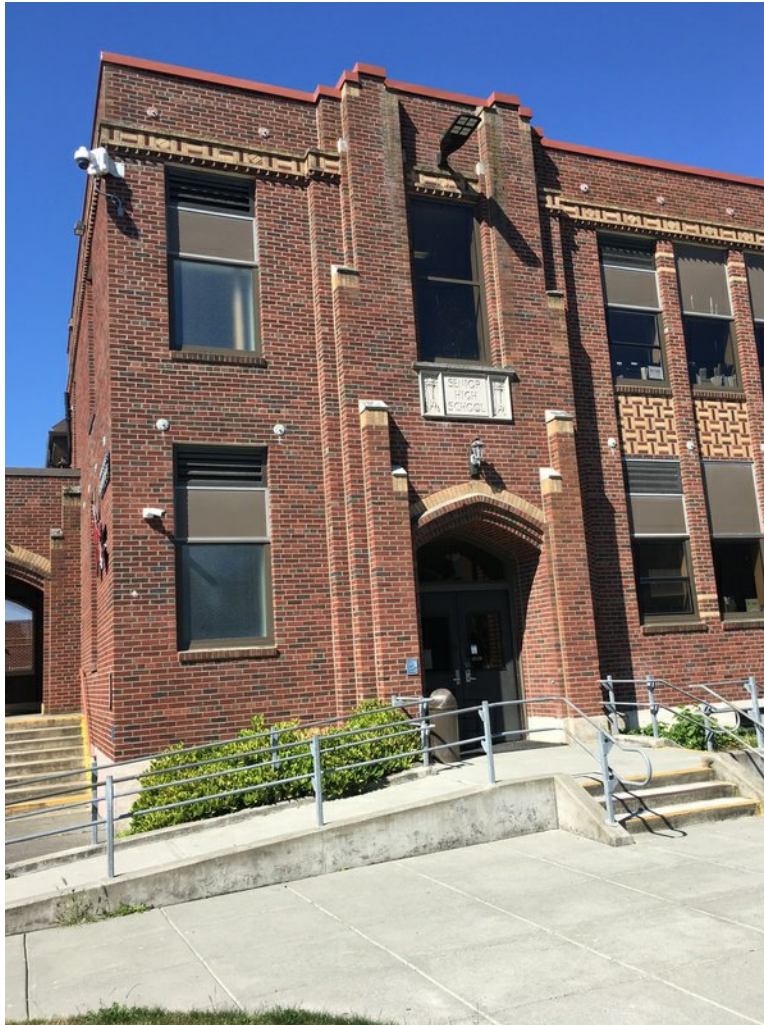
Figure 1-1. Main Building, East Entrance

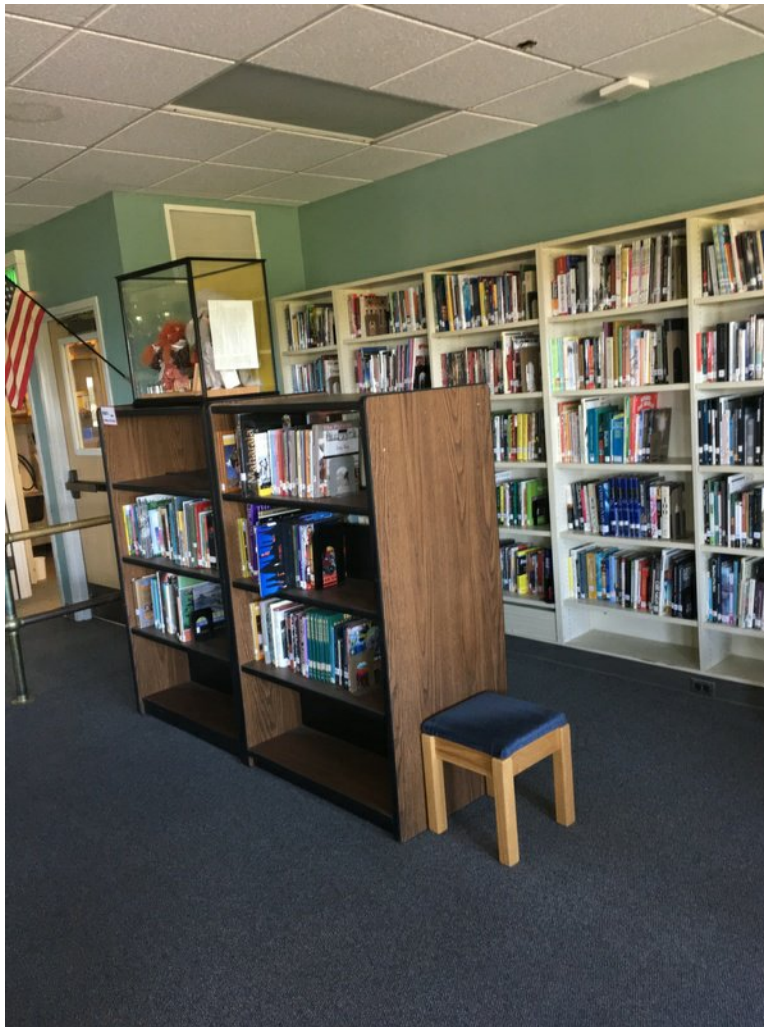
Figure 1-6. Main Building, Library

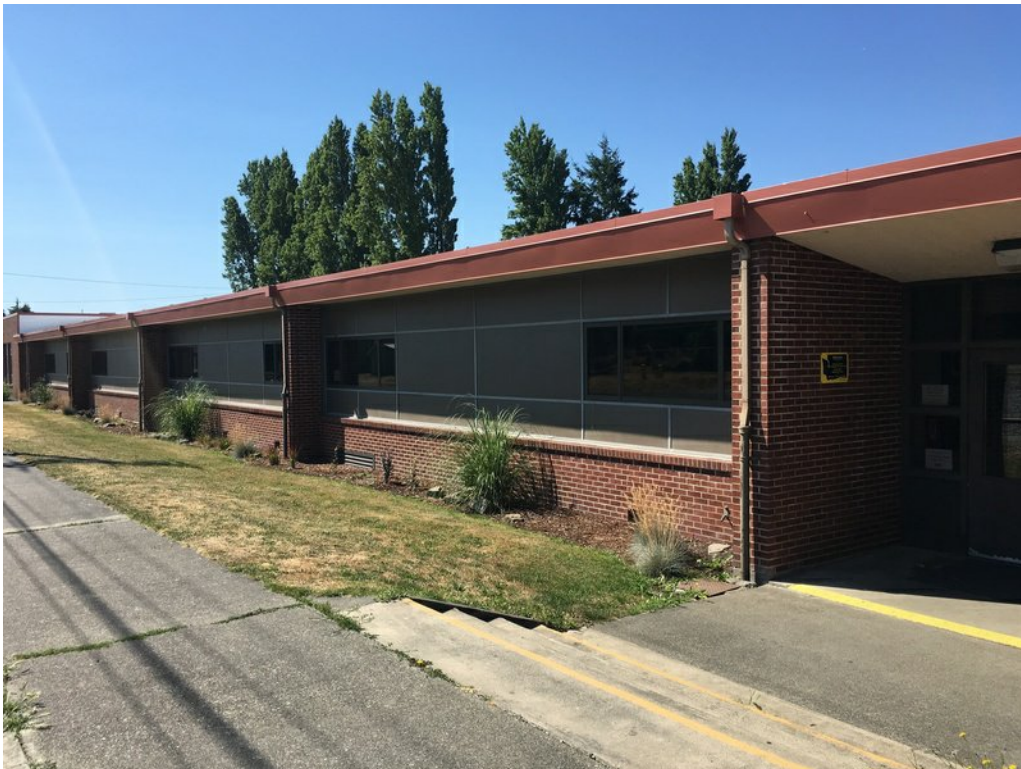
Figure 1-2. Stuart Building, East Elevation
